# Manhole Inspection Summary

Manhole # S05II2012MH

**Location** Address: **2506 LARRYVALE RD**

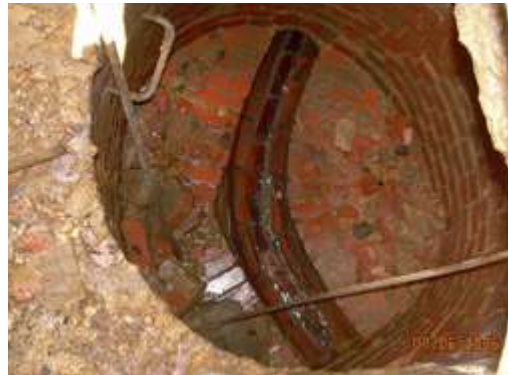
Top View

Adjustment and Barrel infiltration. Bench debris.

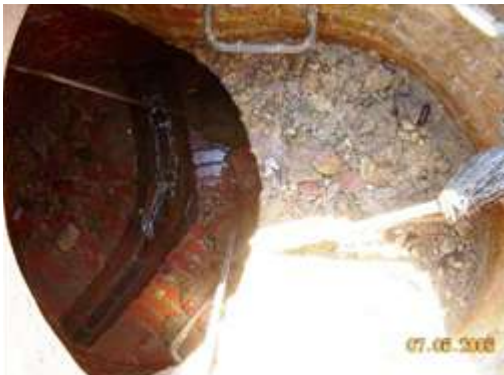
Defect

Frame leaks. Corbel offset. Adjustment infiltration. Bench debris.

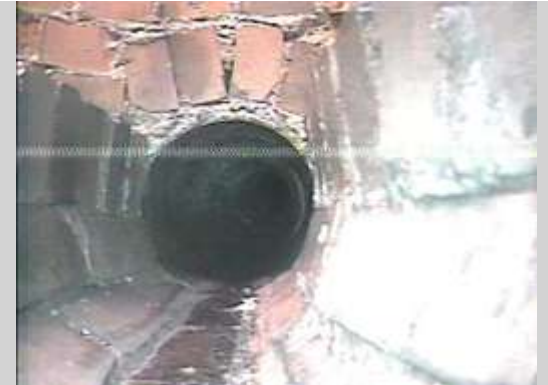
### 8 in. Circular Gravity Sewer Pipe Out @ 12 O'Clock

Barrel deterioration and infiltration.

Infiltration: **Evidence** Pipe Seal Cond: **Unknown**

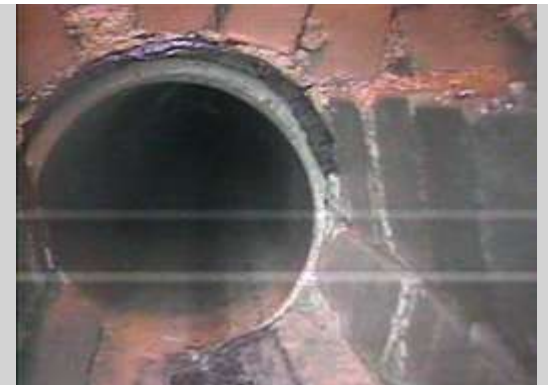
### 8 in. Circular Gravity Sewer Pipe In @ 4 O'Clock

Infiltration: **Evidence** Pipe Seal Cond: **Cracked**
